The
LaQUE CENTER
FOR CORROSION TECHNOLOGY, INC.

**SEAWATER CREVICE CORROSION RESISTANCE OF
STAINLESS STEELS COATED WITH
SILANE AND ANTIFOULING PAINT SYSTEMS**

**FINAL REPORT
CONTRACT N00014-01-C-0177**

August 2002

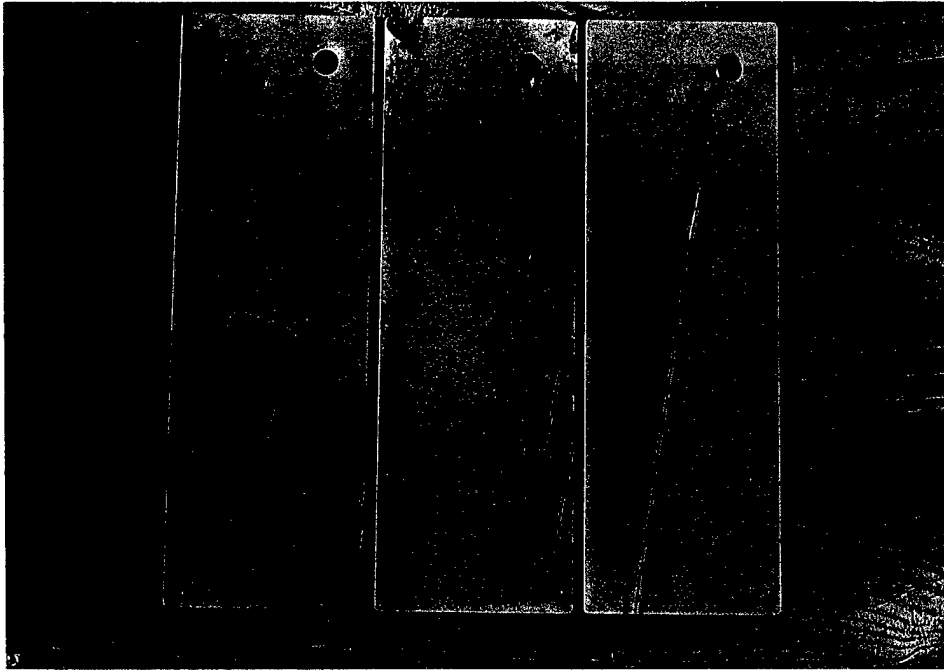
FIGURE 5 – View of partially cleaned S31603 specimens with 80% silane coverage (left to right: Silane A, B and C).

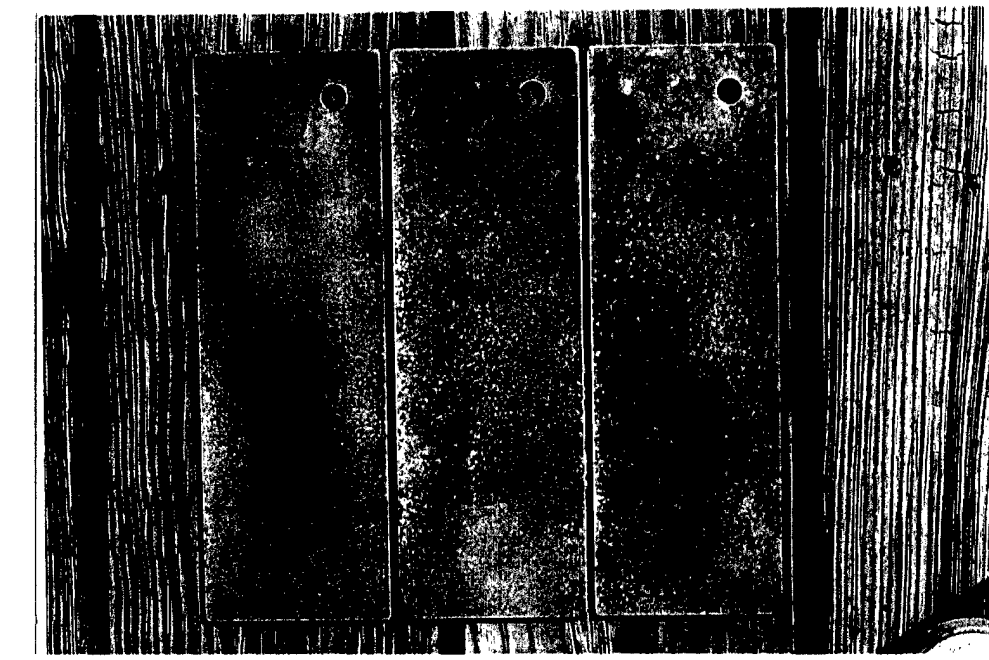
Figure 24.1 2609-04-020-19

In contrast to the above, final inspection of the 18 partially coated N087367 specimens (Figures 24.1 to 25.3) revealed no evidence of corrosion within the areas coated (20% and 80%)
